Intrinsyx Environmental Case Study

Endophyte-Enhanced Phytoremediation of Chlorinated VOCs Manufacturing Site in Danville, IL

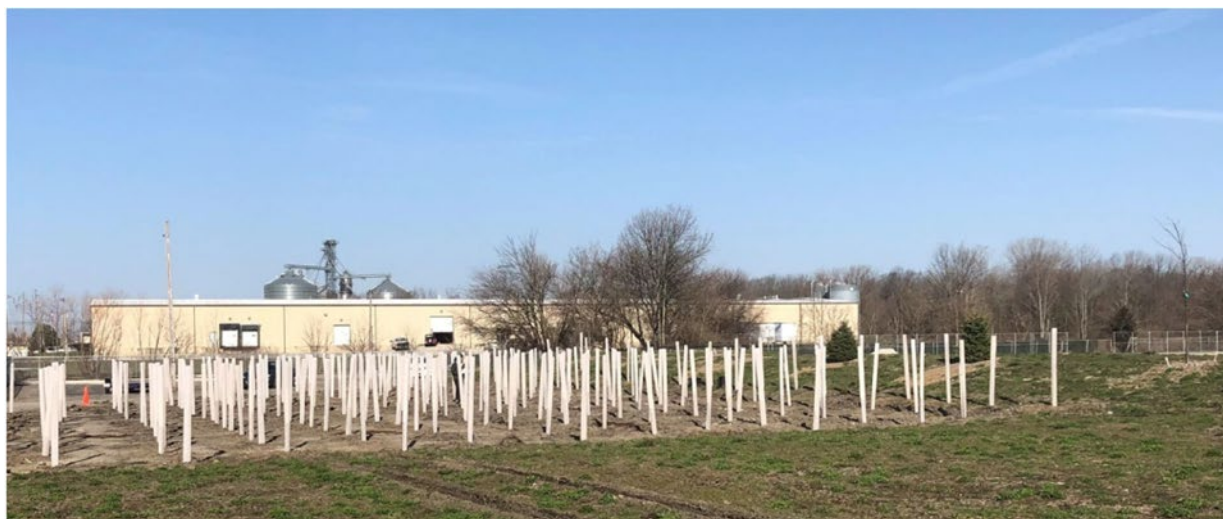
Figure 4: Initial image of the trees following planting in 2018.

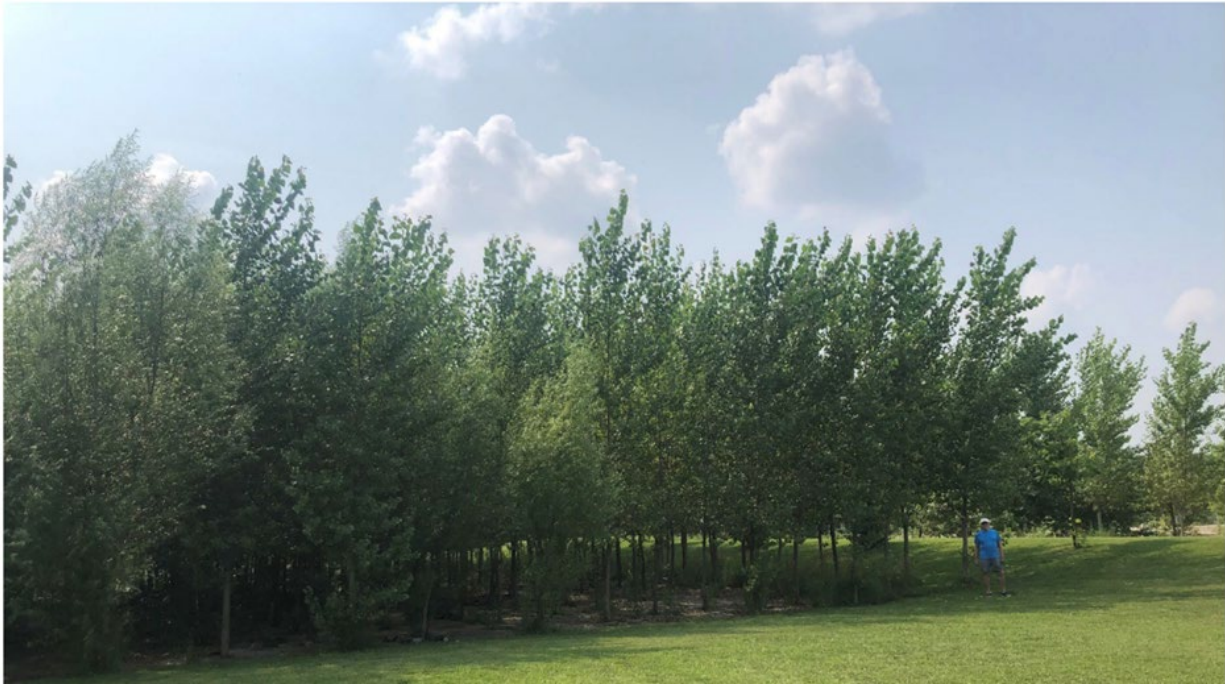
Figure 5: Image of trees following more than three years of growth.
