Intrinsyx Environmental Case Study

Endophyte-Enhanced Phytoremediation - Petroleum Hydrocarbons Former Diesel & Gasoline Transfer Station, Dos Palos, CA

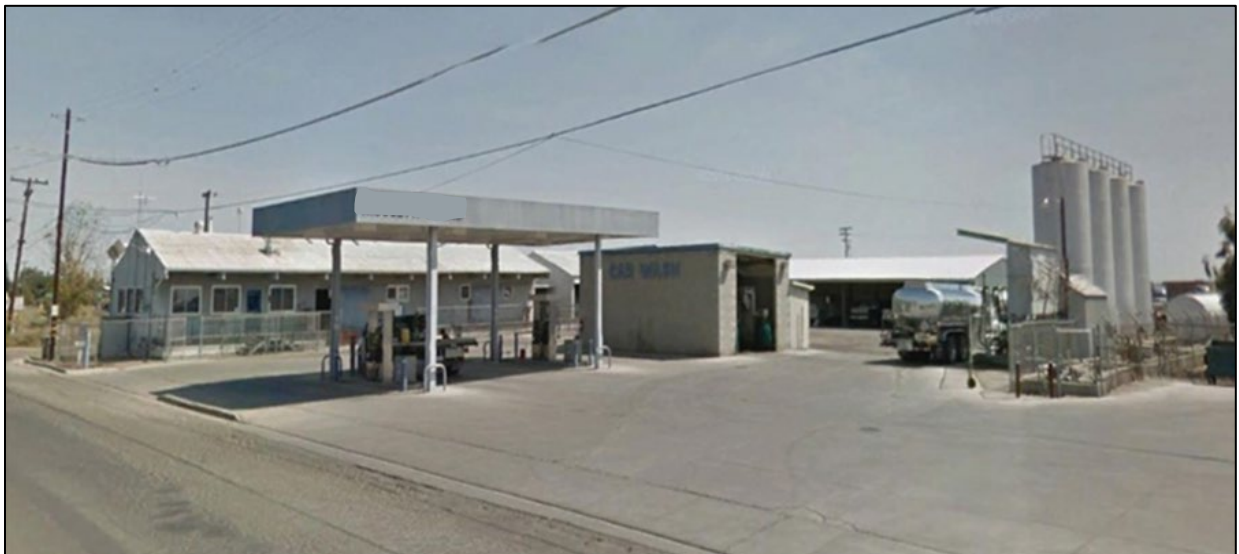
Figure 1: Former gas station and fuel transfer terminal in the Central Valley, CA

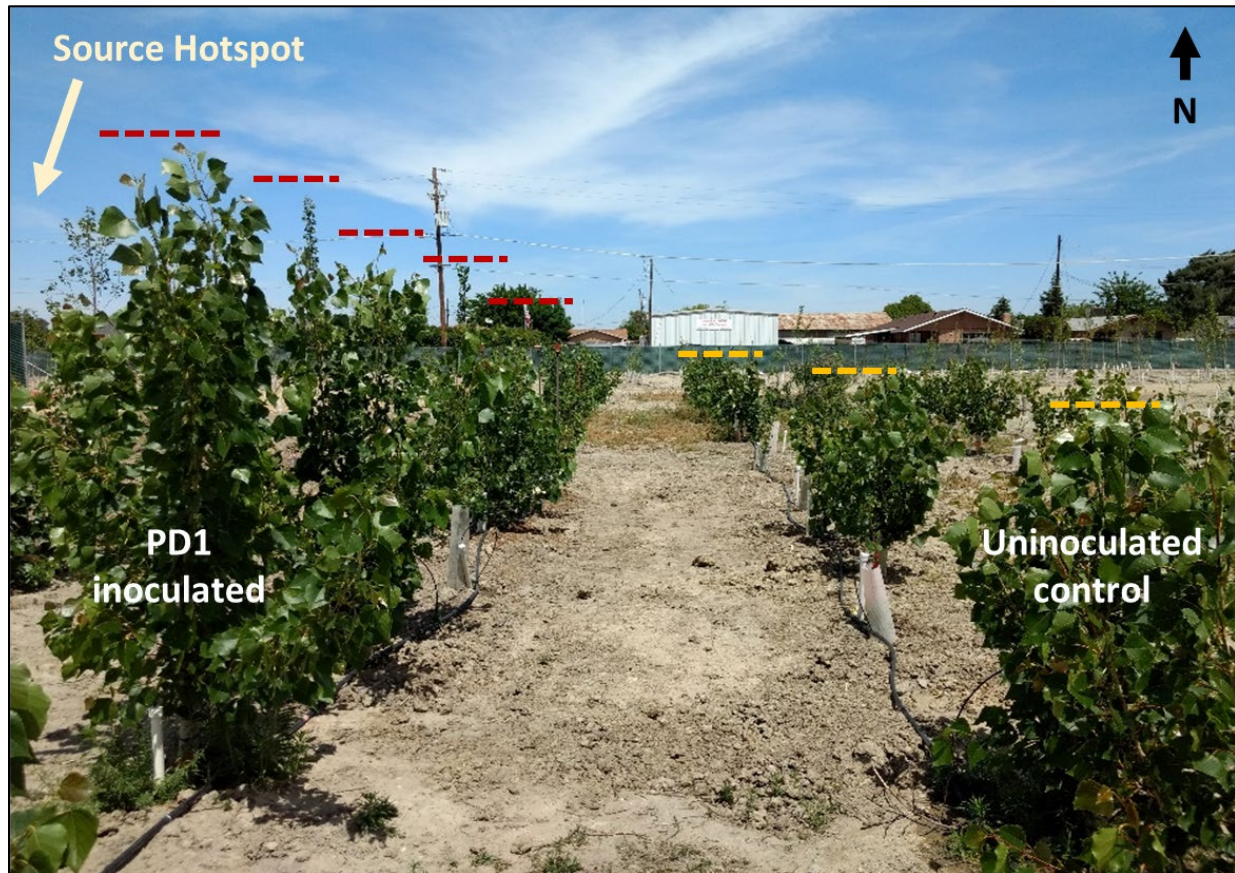
Figure 5: Picture showing growth differences of PD1 inoculated vs uninoculated hybrid poplars on the site

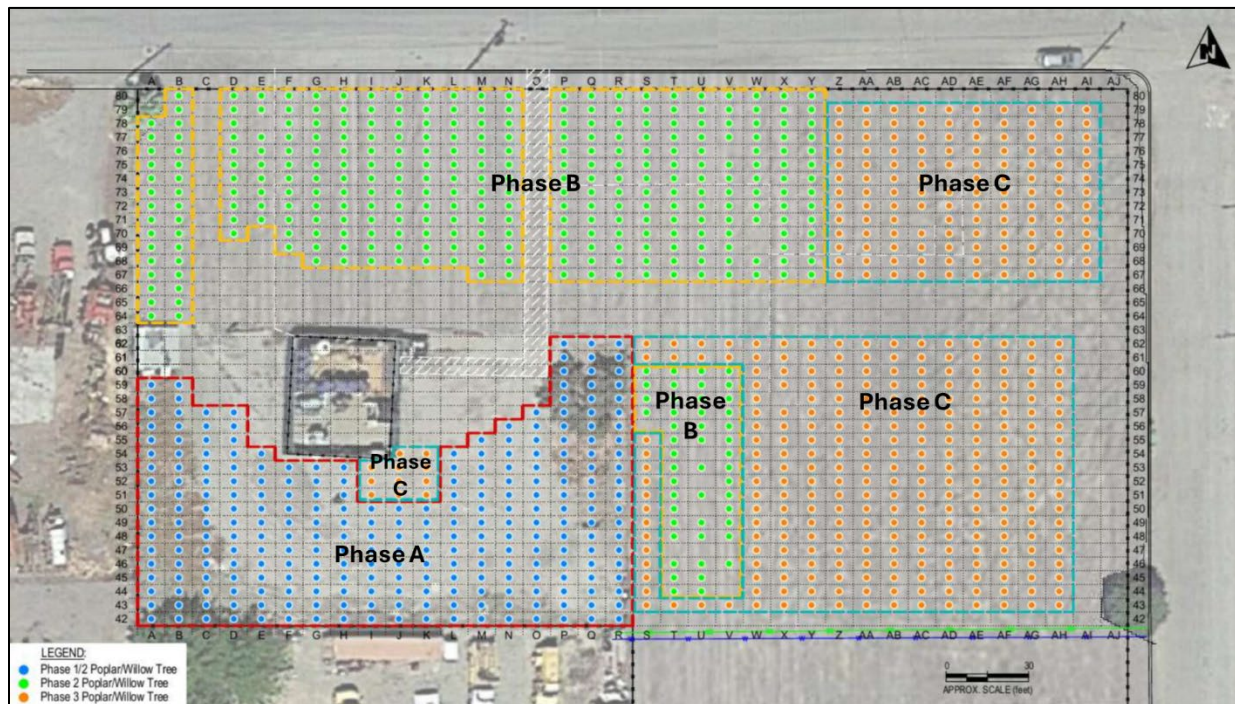
Figure 6: Map showing Phase B and Phase C expansions (relative to Phase A)

After the successful recovery of the trees in Phase A, hybrid poplars and willows were planted across the entire site and inoculated with PD1 endophytes in Phase B and C bringing the total to 1,400 trees (see Figure 6). The endophytes provided enhanced establishment for trees planted in phases B and C, resulting in a 98% survival rate. The rate of treatment by endophyte-assisted hybrid poplars exceeded the rate of treatment by the groundwater pump-and-treat and the soil vapor extraction systems, eventually leading to the decision by the Central Valley Regional Water Quality Control Board to discontinue the previous systems and allow phytoremediation to be the only type of remediation on the site. Between May and September 2019, the client installed three temperature and oxidation-reduction potential (ORP) sensor probes; installed two pressure transducers/piezometers; and collected carbon dioxide flux samples from twenty-five sampling points, current planting density of 870 trees per acre.

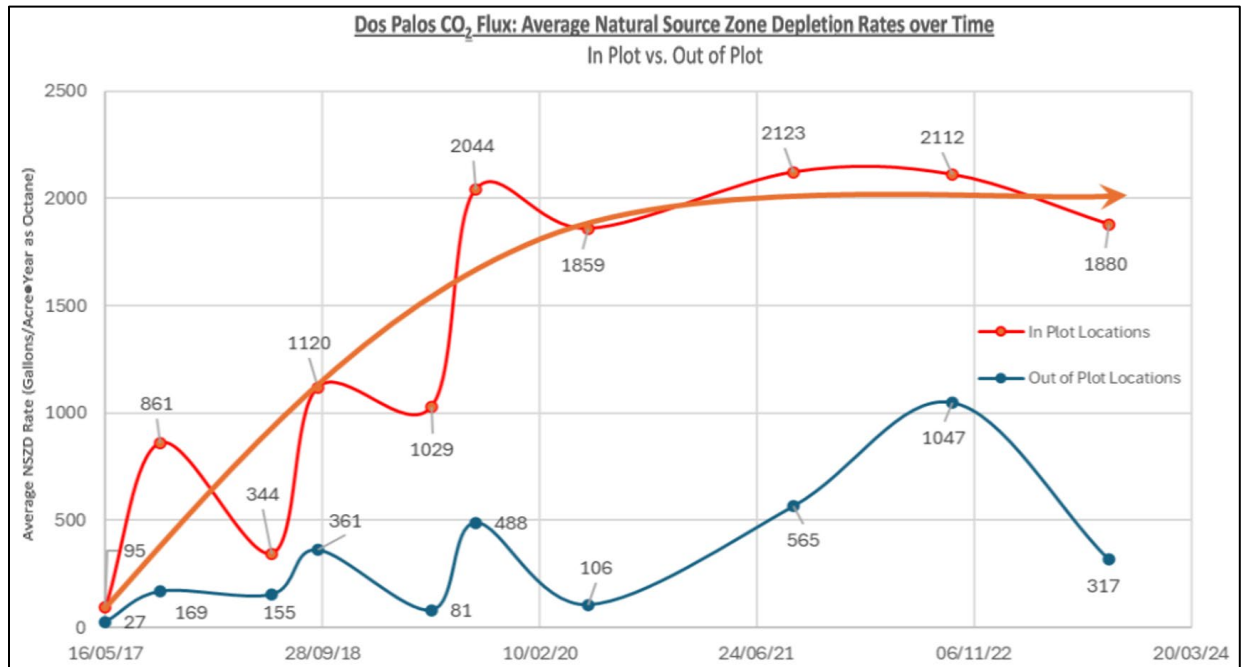
Figure 7: Average Natural Source Zone Depletion rates over time with the red line showing in-plot CO₂ flux locations and the blue line showing out-of-plot CO₂ flux locations

A year-over-year increase in in-plot natural source-zone depletion (NSZD) rates after planting inoculated trees shows that the trees accessed the source zone and used the contaminated water as part of their natural process (shown in Figure 7).

Comparison of the NSZD rates (gallons/year) inside and outside of the planted areas and within similar soil concentrations zones shows elevated hydrocarbon biodegradation rates within the phytoremediation test area. The magnitude of the increase in the NSZD rates varies relative to the hydrocarbon concentration in the vadose zone soil. For high-concentration zones (1,000-10,000 mg/kg diesel), the increases range from 2.7 to 4.5 times greater NSZD rates than out-of-plot zones with high concentrations. For medium concentration zones (100-1,000 mg/kg diesel), the increases range from 1.9 to 3.4 times greater NSZD rates than out-of-plot zones with medium concentrations. The enhancement of NSZD rates is due to several factors associated with planting trees at the site.

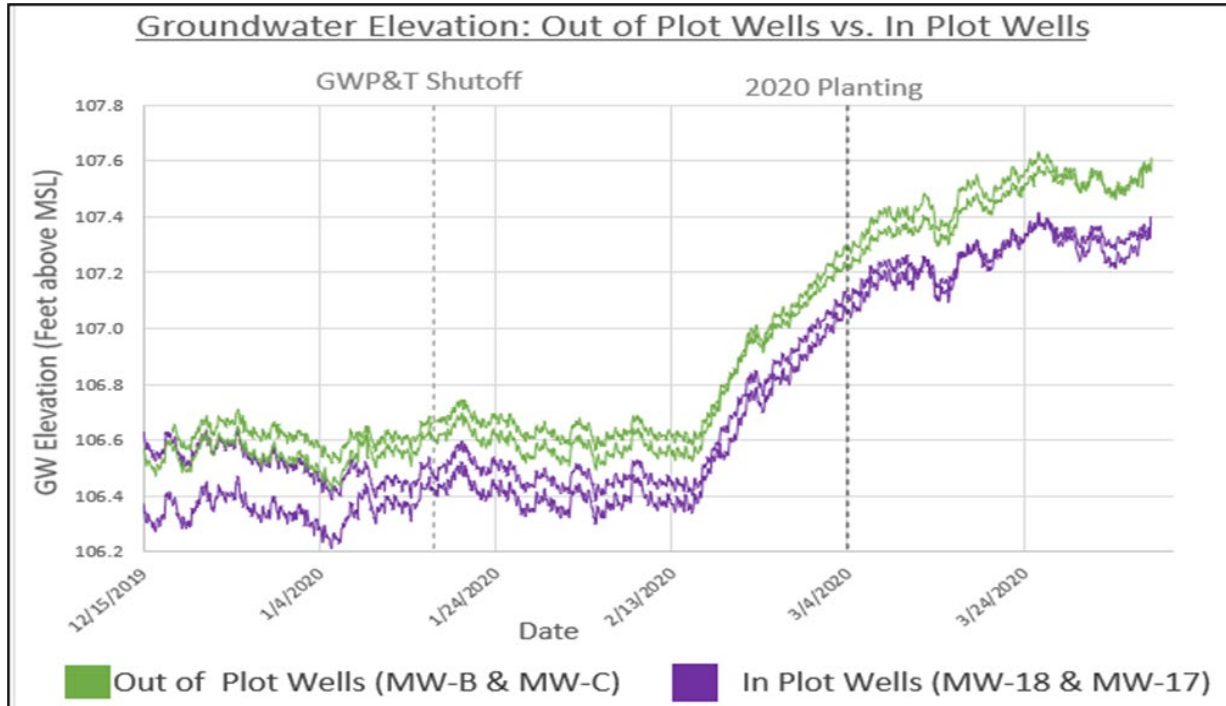
Figure 9: In-plot vs out-of-plot groundwater elevation (feet above MSL) with green representing an average of out-of-plot wells and purple representing an average of in-plot wells

Decreases in the in-plot and off-plot groundwater elevation show that trees gained hydraulic control of the site and began mitigating the migration of contaminants off-site within one year of planting (shown in Figure 9). Before the groundwater pump and treat system was shut off, in-plot and off-plot groundwater monitoring wells had very similar groundwater elevation levels. In-plot groundwater levels were hovering around 106.6 feet above mean sea level (amsl), and off-plot groundwater levels were hovering around 106.5 feet amsl. After the groundwater P&T system was shut off in January 2020, the trees took control of the water table and created a zone of depression in-plot. The gap between the on-plot and off-plot groundwater has continued to widen over time, showing that the mature trees continue to create a zone of depression, and groundwater is flowing from off-plot to in-plot.

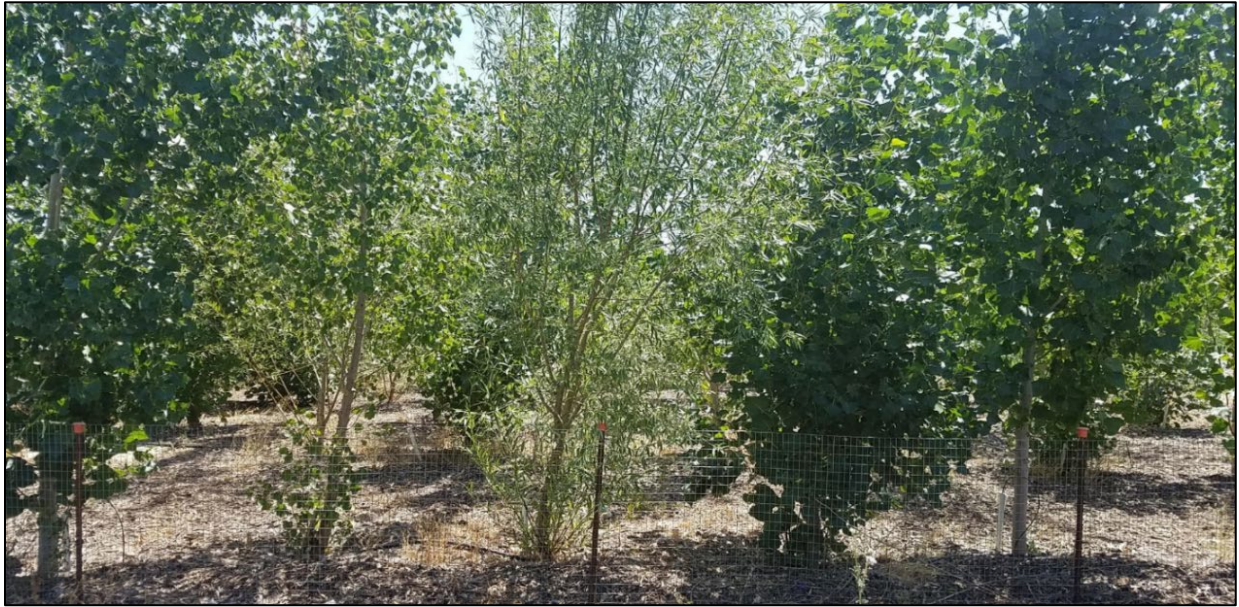
Figure 10: 2021 pictures of trees on the western edge of the site

PD1 endophytes rescued many trees from mortality and provided healthy growth of 95% of trees on site, despite phytotoxic concentrations, the daily groundwater consumption rate is about 17,400 to 43,500 gallons of water per acre planted. The average capture rate of the current GWP&T system is about 10,224 gallons per day. The yearly average groundwater consumption of the trees exceeded that of the GWP&T system during the 2020 growing season. The pressure transducer data collected confirms that the groundwater elevations in the tree plot areas are 0.1 to 0.2 feet lower than those outside the plot. In addition, the trees improve conditions for biodegradation near the root zone. The petroleum hydrocarbons in groundwater and soil are degraded in enhanced rhizosphere and drawn to the tree roots and then are rapidly degraded. In 2020, [California Waterboard permitted the shutdown of the groundwater pump and treat system](#) as well as the soil vapor extraction systems (Central Valley Regional Water Quality Control Board, 2020). In 2022, the California Waterboard authorized the deconstruction of both pump and treat and SVE systems. The groundwater and soil concentrations are steadily decreasing, and site closure is expected in approximately 5 years (from system decommissioning). By shutting down the pump and treat and SVE systems, the site owner saved over \$1M/year in operation and maintenance costs.

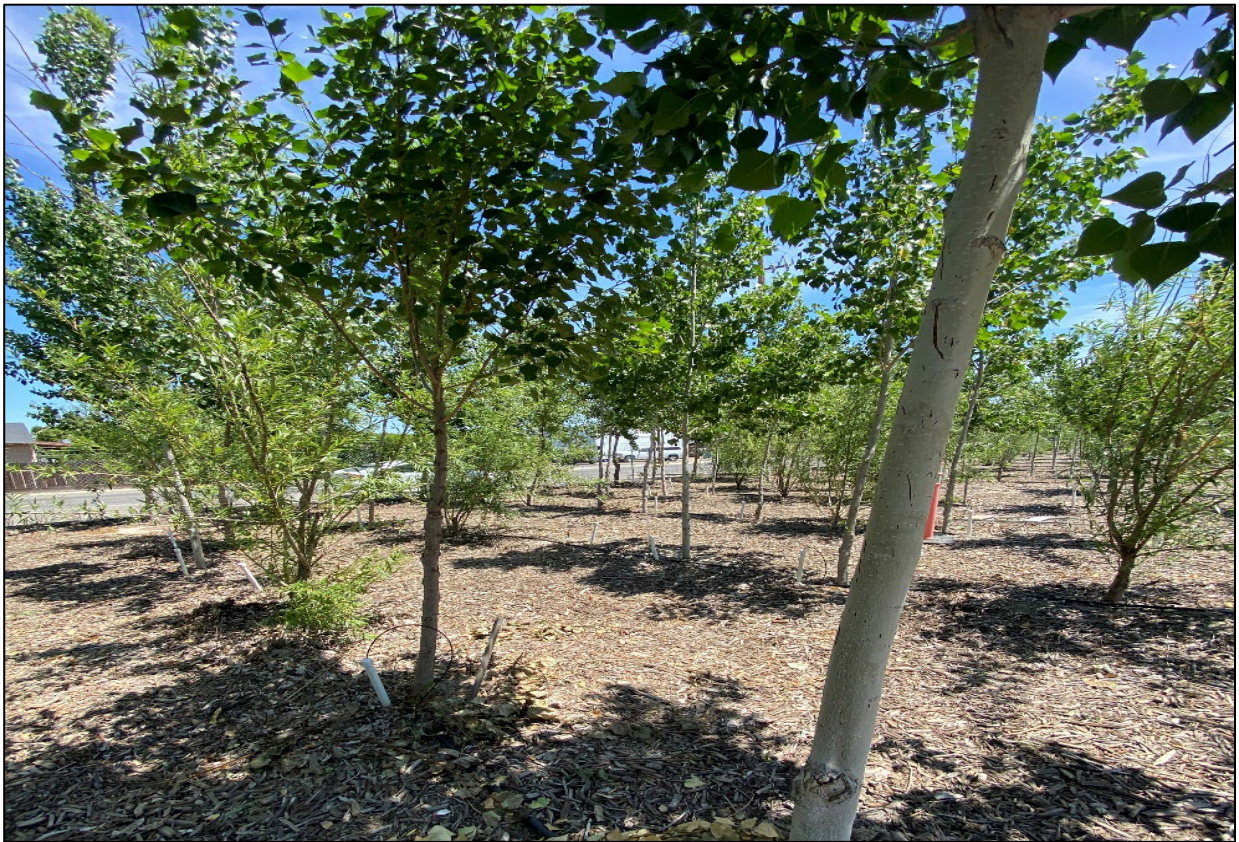
Figure 11: In 2021 Trees are beginning to resemble a forest, and local residents have requested removing fencing to be able to view the trees more clearly
